3.6 GEOLOGY AND SOILS

3.6.1 Geology

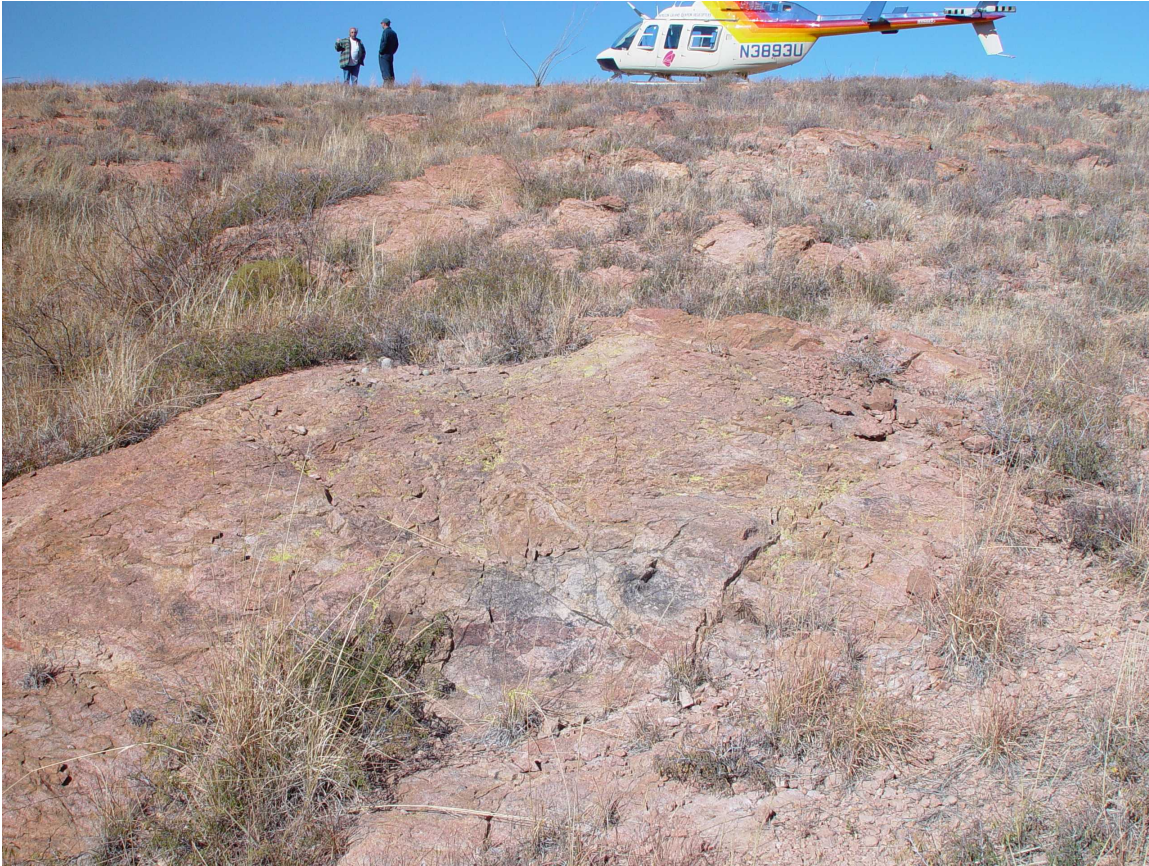
As part of the analysis of roads required by the U.S. Department of Agriculture Forest Service (USFS), Terracon conducted a geotechnical evaluation of the proposed project area on the Coronado National Forest (Terracon 2002). Relatively intact bedrock is near to or exposed at the ground surface along the majority of the Western Corridor on the western side of the Tumacacori Mountains, as shown by the areas of tertiary conglomerate and sandstone in Figure 3.6–2 on national forest land (Terracon 2002). The photograph in Figure 3.6–3 shows exposed bedrock along the Western Corridor. The bedrock would be suitable for supporting poles on a rock bolted base, in which small holes are drilled into the bedrock and the tower is attached with large bolt, as described in Section 4.6, Geology and Soils.

Figure 3.6–3. Exposed Bedrock Along the Western Corridor.

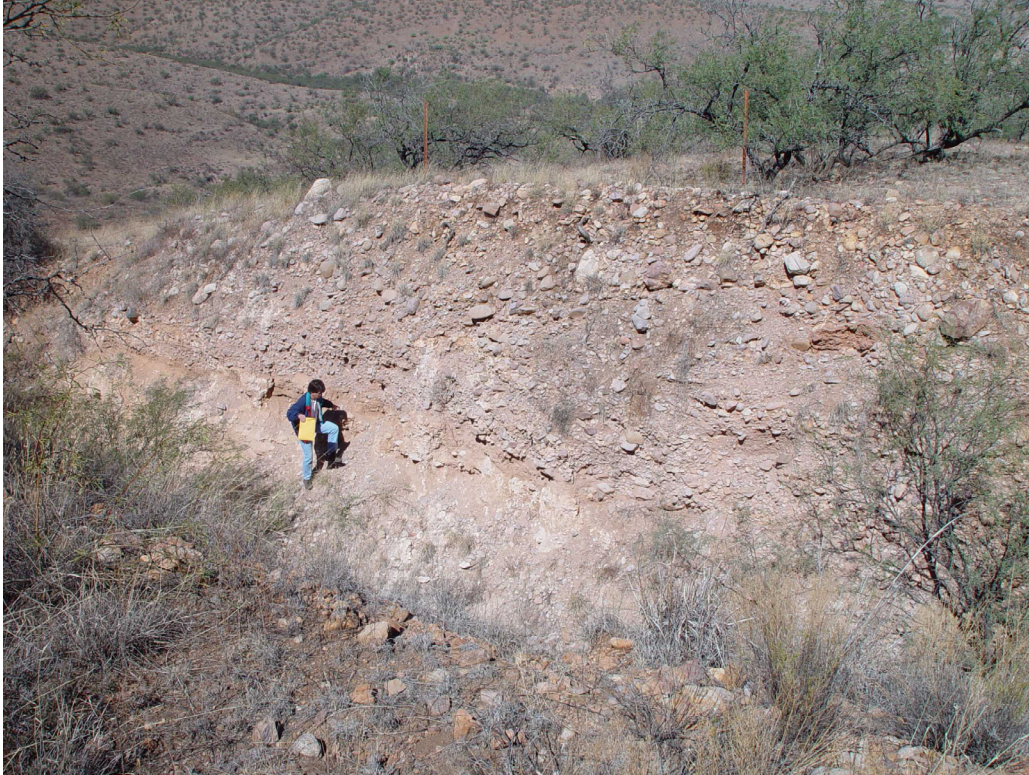
A majority of the Central Corridor near and on the Tumacacori EMA has exposed soil at the surface rather than bedrock, as depicted by areas of Quaternary alluvium in Figure 3.6–1, and as shown in Figure 3.6–4. The foundations for towers along the Central Corridor in these exposed soil areas would most likely require embedment poles, as described in Section 4.6, Geology. The terrain along the Central Corridor is generally defined by a series of hills separated by washes (Terracon 2002).

Figure 3.6–4. Exposed Soil Along the Central Corridor.
